# **Construction Impact Assessment**

Assessment of trees and vegetation patches at  
Delburn Wind farm

**Homewood Consulting Pty Ltd**

24 July 2020

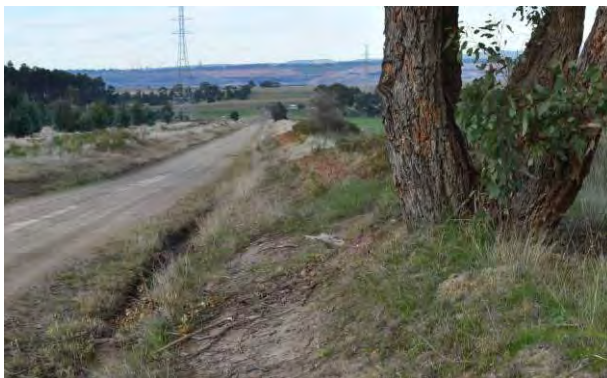
Figure 1: Deans Rd looking east with Tree 10 in the foreground. An example of an unsealed road within the assessment area.

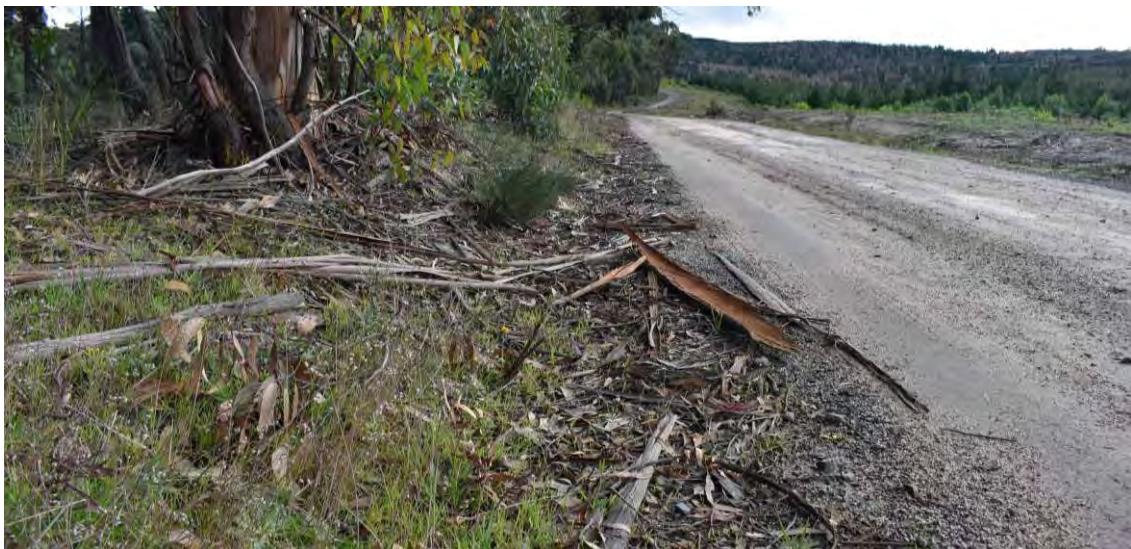
OSMI have stated that all road upgrades will occur at or above grade and within the existing road footprint (P Marriott 2020, pers. comm., 25 June). The construction and usage of roads compacts the soil profile which can impede root growth and function (Figure 6).

Figure 6: Example of heavily compacted existing road surface on the right; creating unfavourable conditions for root growth. Contrasting with the uncompacted vegetation patch on the left.

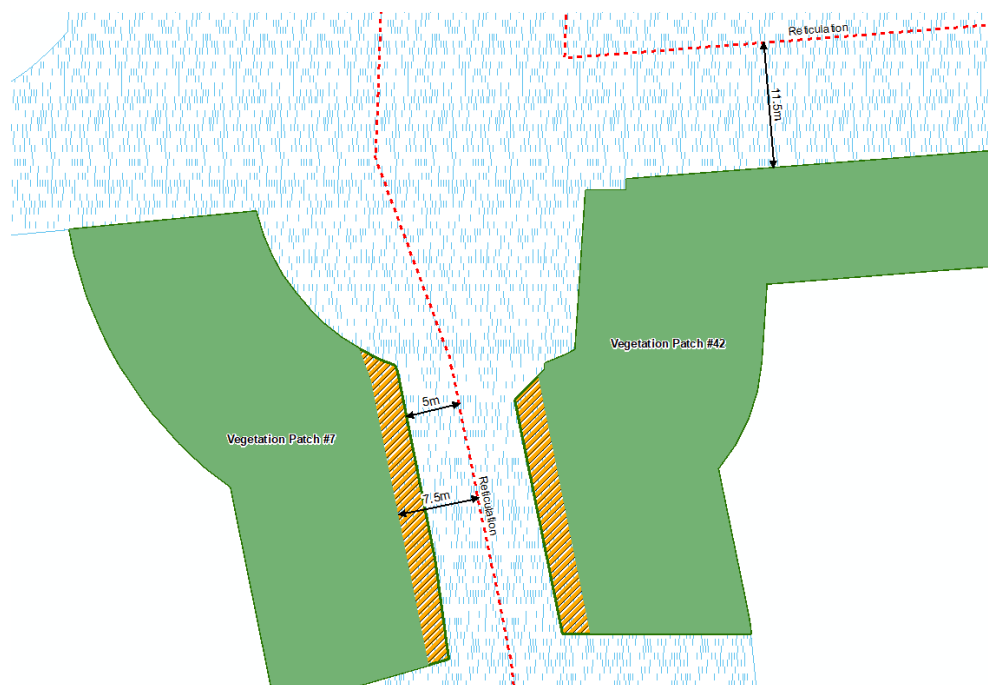
The proposed reticulation is already at least 7m clear of the majority of the assessed vegetation patches. Where portions of vegetation patches are located less than 7m from proposed reticulation, these portions within this 7m buffer should be considered lost (Figure 7).

Figure 7: Orange hatched area representing lost portions of vegetation patches

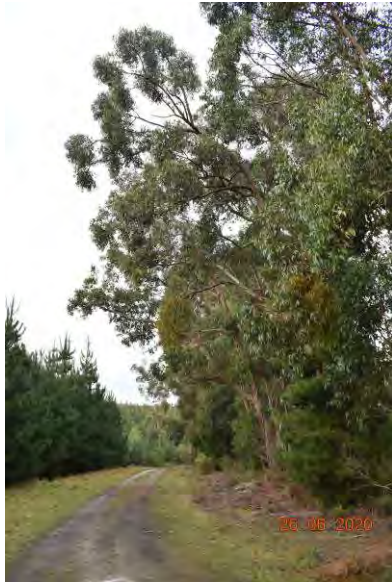
Figure 8: Vegetation patch 54 with canopy overhang classified as 'High'

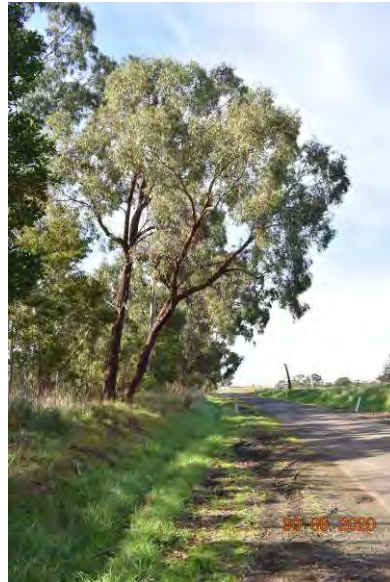
Figure 9: Vegetation patch 57 with canopy overhang classified as 'Medium'

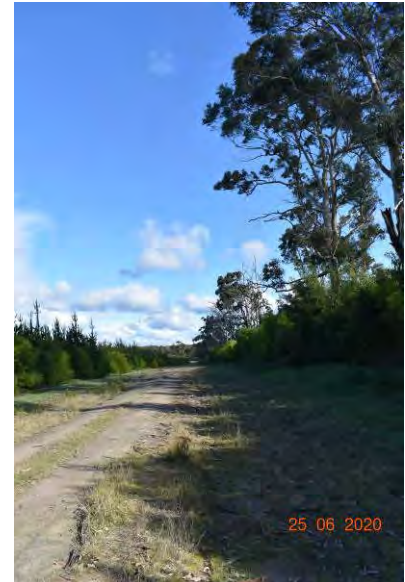
Figure 10: Vegetation patch 04 displaying 'Low' canopy overhang

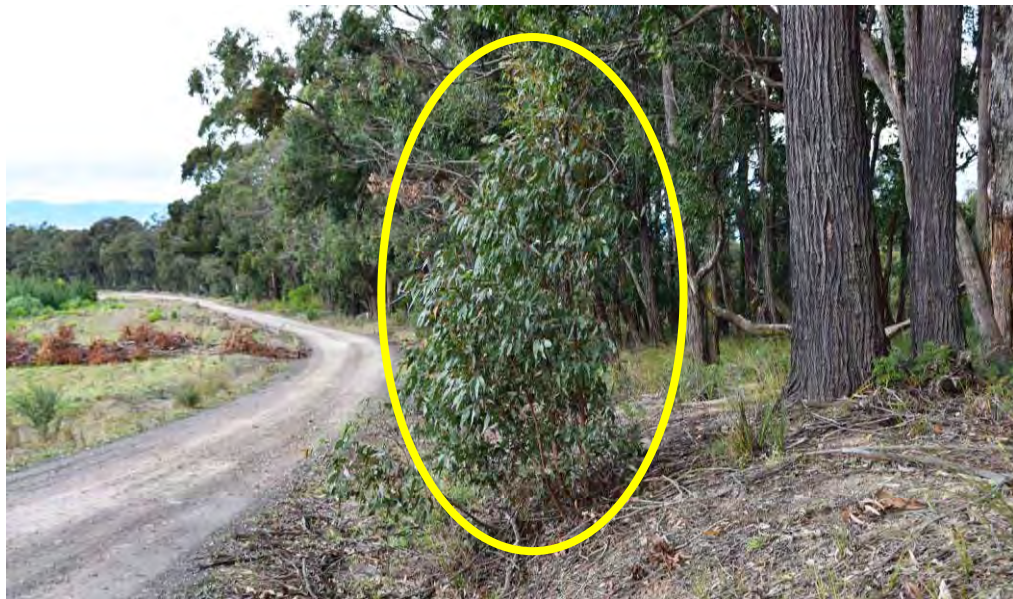
Across the site some young trees were observed on the edge of vegetation patches, growing within drainage channels adjacent to existing roads (Figure 11). These trees will require removal in order to facilitate the proposed upgrade.

Figure 11: Juvenile tree growing within existing drainage outlined in yellow
