**APPENDIX A**

# Results of Desktop Study

## DESKTOP STUDY

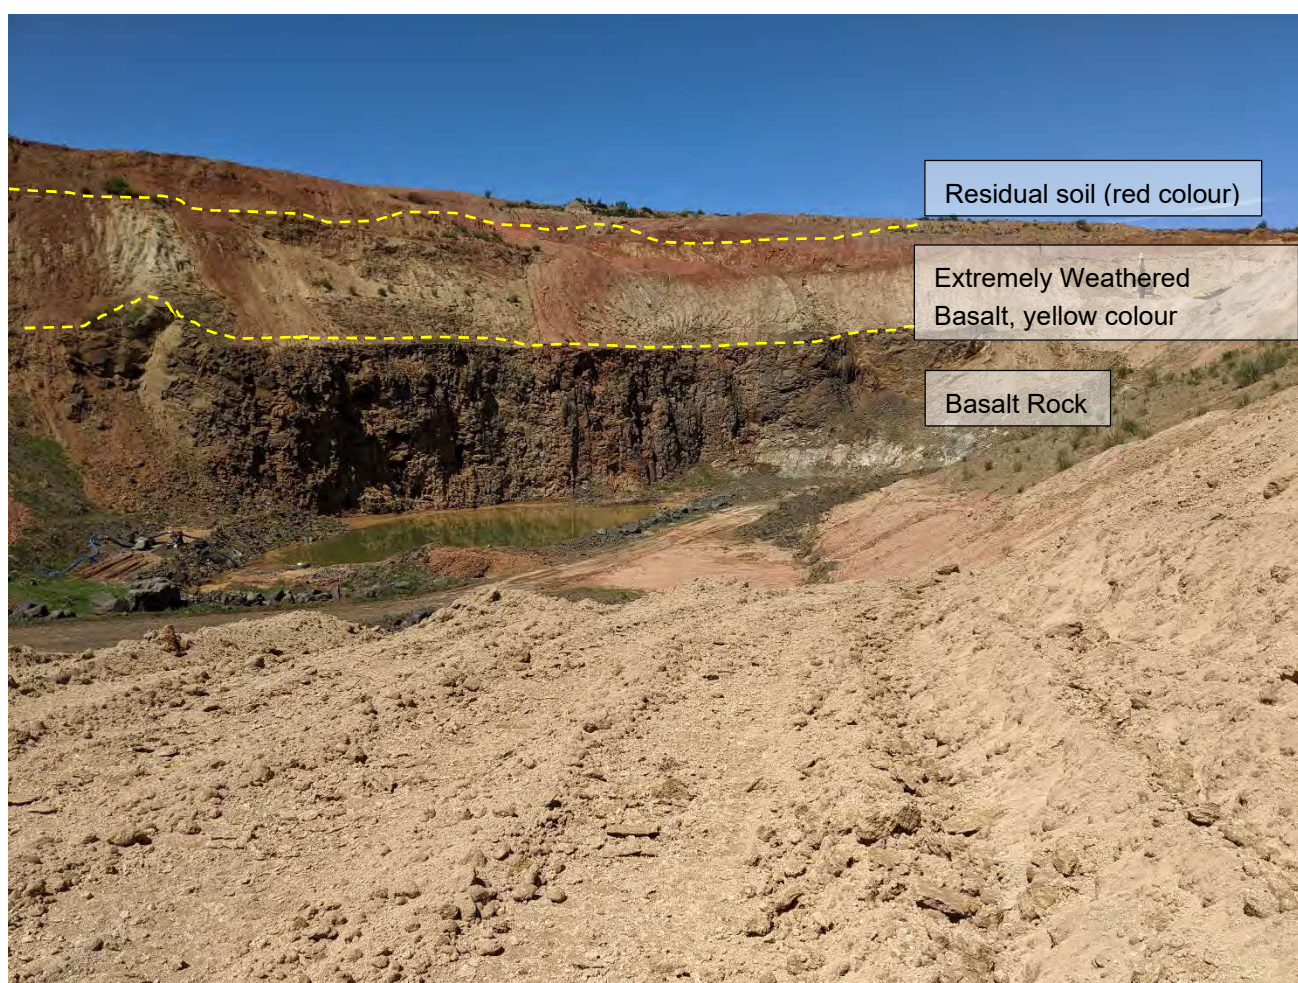
**Plate A1: General profile exposed in Kennedy Haulage Quarry**

Exposures through the Thorpdale Volcanics observed in the Kennedy Haulage Quarry along with borehole logs provided by quarry management indicate a varied subsurface profile through this material. In general, the profile comprises a 6 m to 7 m thick layer of high plasticity clay inferred to have derived from the in situ weathering of the Thorpdale Volcanics. This is underlain by inferred extremely weathered basalt, which occurs as a hard clay to low strength rock and has a characteristic yellow colour. There appears to be multiple layers and varied distribution of the extremely weathered basalt before competent basalt rock is typically encountered at a depth of 15 m or more, noting that at some locations in the vicinity of the quarry, the basalt rock is encountered near surface. A profile within the Thorpdale Volcanics observed at the Kennedy Quarry is shown in Plate A1.

Silcrete rock was observed at one location within the vicinity of the quarry and appears to be present near the top of the extremely weathered basalt.

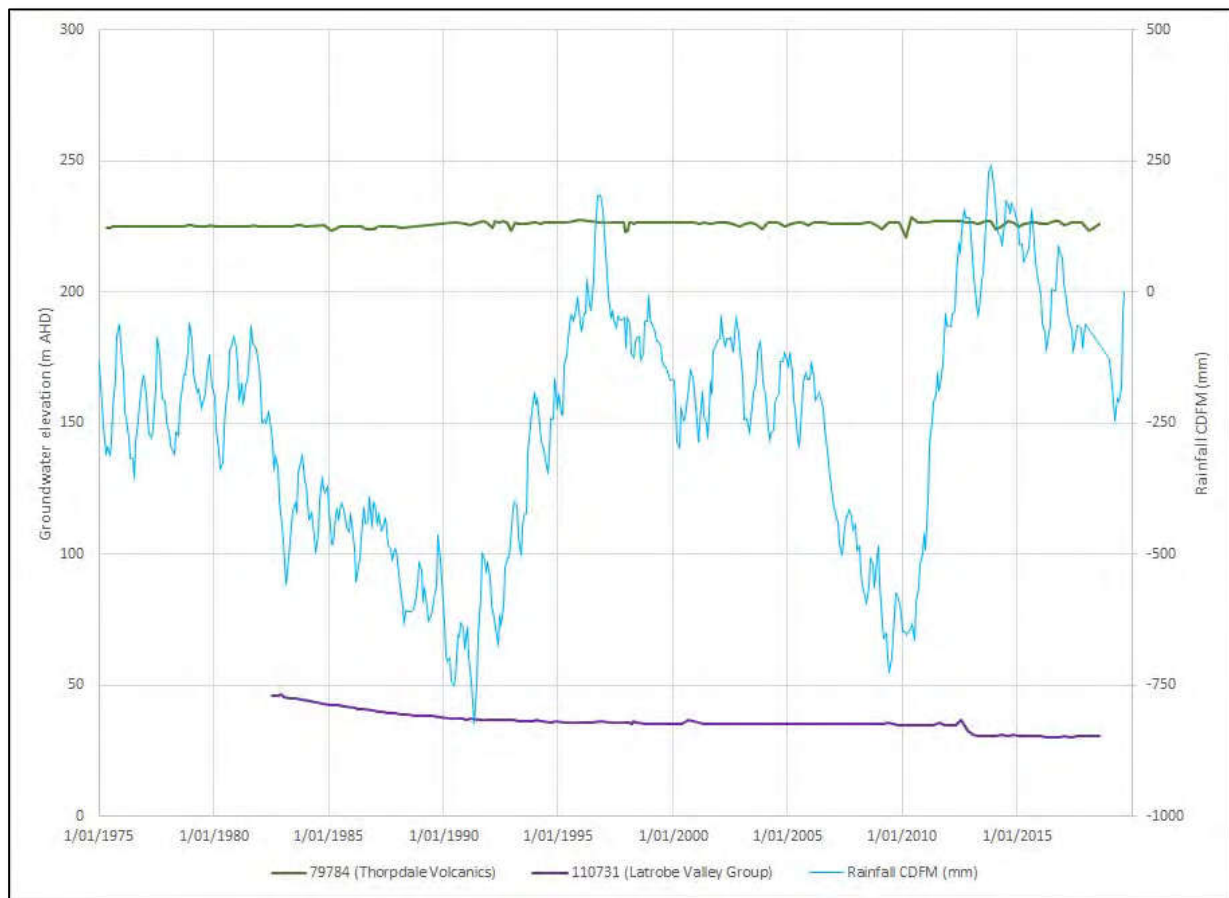
**Plate A2: Groundwater level at registered wells**

A search of registered boreholes on the Water Management Information System (WMIS) maintained by the Department of Environment, Land, Water and Planning (DELWP) was undertaken to identify the monitoring wells for which long term groundwater level monitoring data may be available. Two monitoring wells with groundwater level information (IDs 110731 and 79784) were identified within 5 km of the site. The groundwater levels observed in these bores are shown in Plate A2, along with the rainfall residual mass curve. Rainfall data was obtained from the Mirboo North Water Board weather station (BOM station #85282), approximately 7 km south-west of the project area.

Bore 110731, located approximately 2.5 km to the east of the project area, is recorded as 200 m deep, but the screened interval and lithology is not reported. Based on the surface geology and depth, this bore is likely to intersect the Latrobe Valley Group. A declining in groundwater level of approximately 9 m was recorded between 1982, when the well was installed, and 2000. Groundwater level then remained relatively stable from 2000 to 2012, declined by approximately 4 m from 2012 to 2013, then remained relatively stable to 2018. The most recent groundwater level recorded (August 2018) indicates a depth to water of approximately 62 m, corresponding to an elevation of approximately 30 m AHD.

Bore 79784, located approximately 4.9 km to the west, is screened from 21 m bgl to 37 m bgl, within the Thorpdale Volcanics. The groundwater level has remained relatively stable over the period of monitoring (from 1975 to 2018). The most recent groundwater level (August 2018) records indicate groundwater to be approximately at the ground surface level, corresponding to an elevation of 226 m AHD.

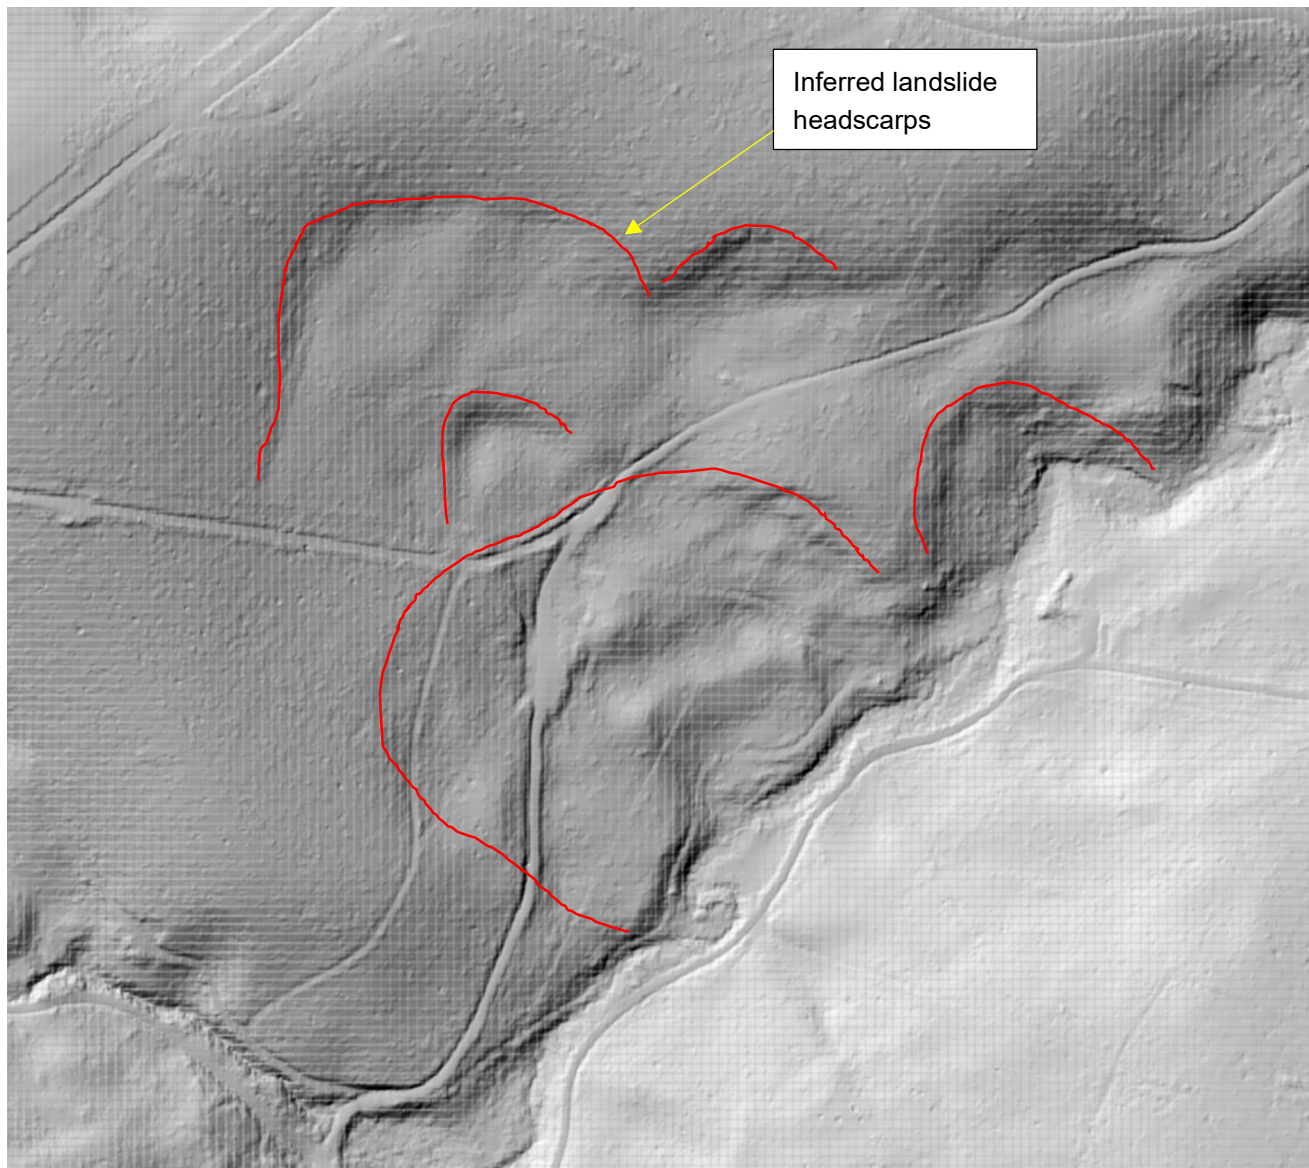
**Plate A3: Example of inferred landslide within project area**

Review of the digital terrain model by a principal engineering geologist has been undertaken to identify areas that appear to have been subject to previous slope instability. The residual soils of the Thorpdale Volcanics are known to be susceptible to landslides, with several landslides previously occurring around the Thorpdale area. Relict landslides have been identified based on indications in the digital terrain model, similar to that presented in Plate A3.

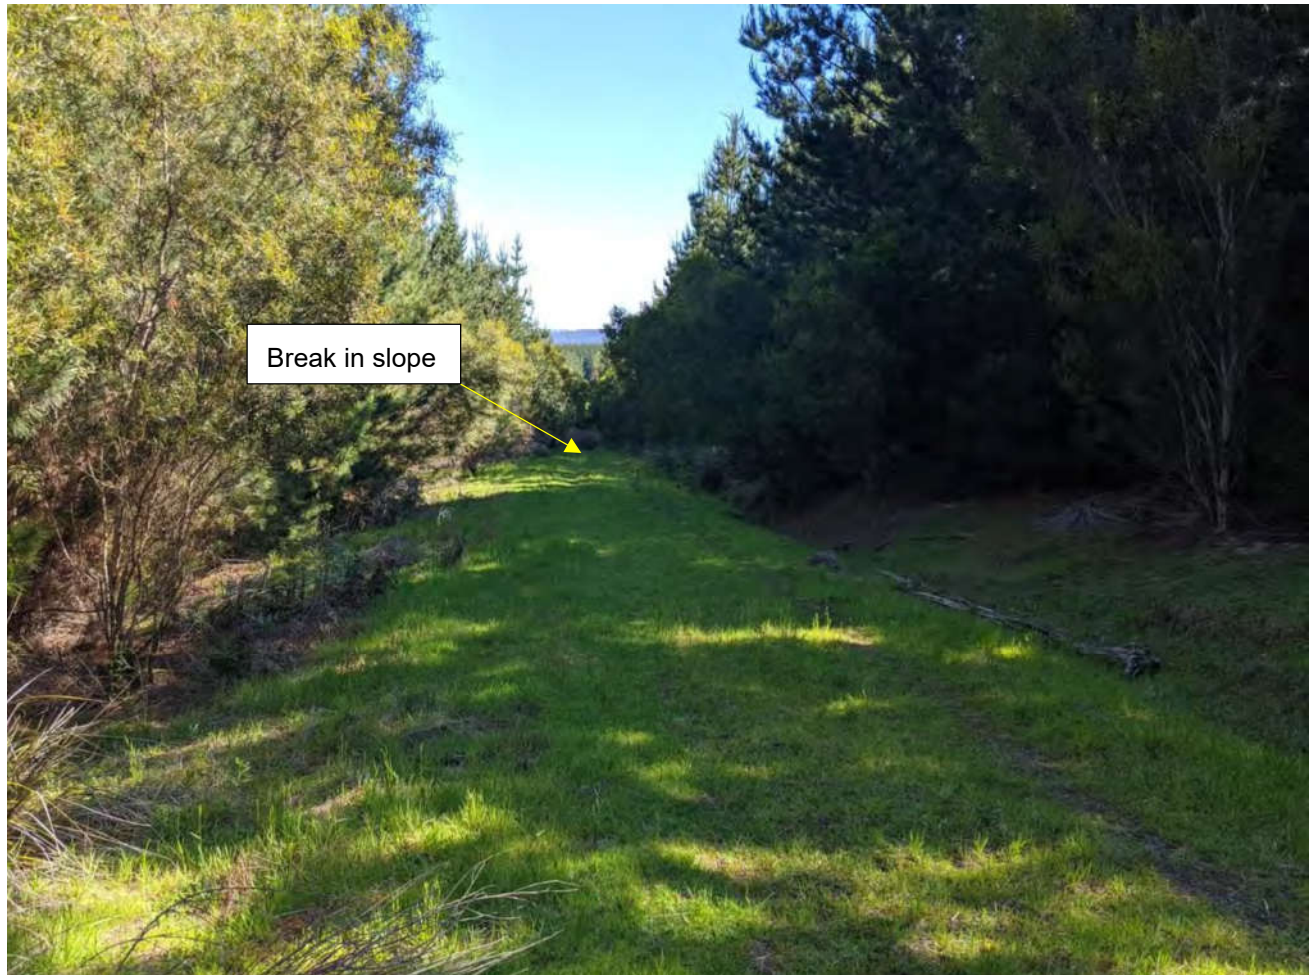
**Plate A4: Example of stepped ground, track into WTG41**

Field visit suggested that whilst there is evidence for past large scale landslide activity, there is no evidence for recent large scale landslide activity. Slightly hummocky and stepped ground observed in some locations appears to be indicative of historical landslides, probably thousands of years old. An example of stepped ground is presented in Plate A4 where the distance between breaks in slope is several hundred metres.

- Due to inferred relict landslide features, the site has an irregular, or 'stepped' surface over some areas, with several hundred metres separating prominent breaks in slope.

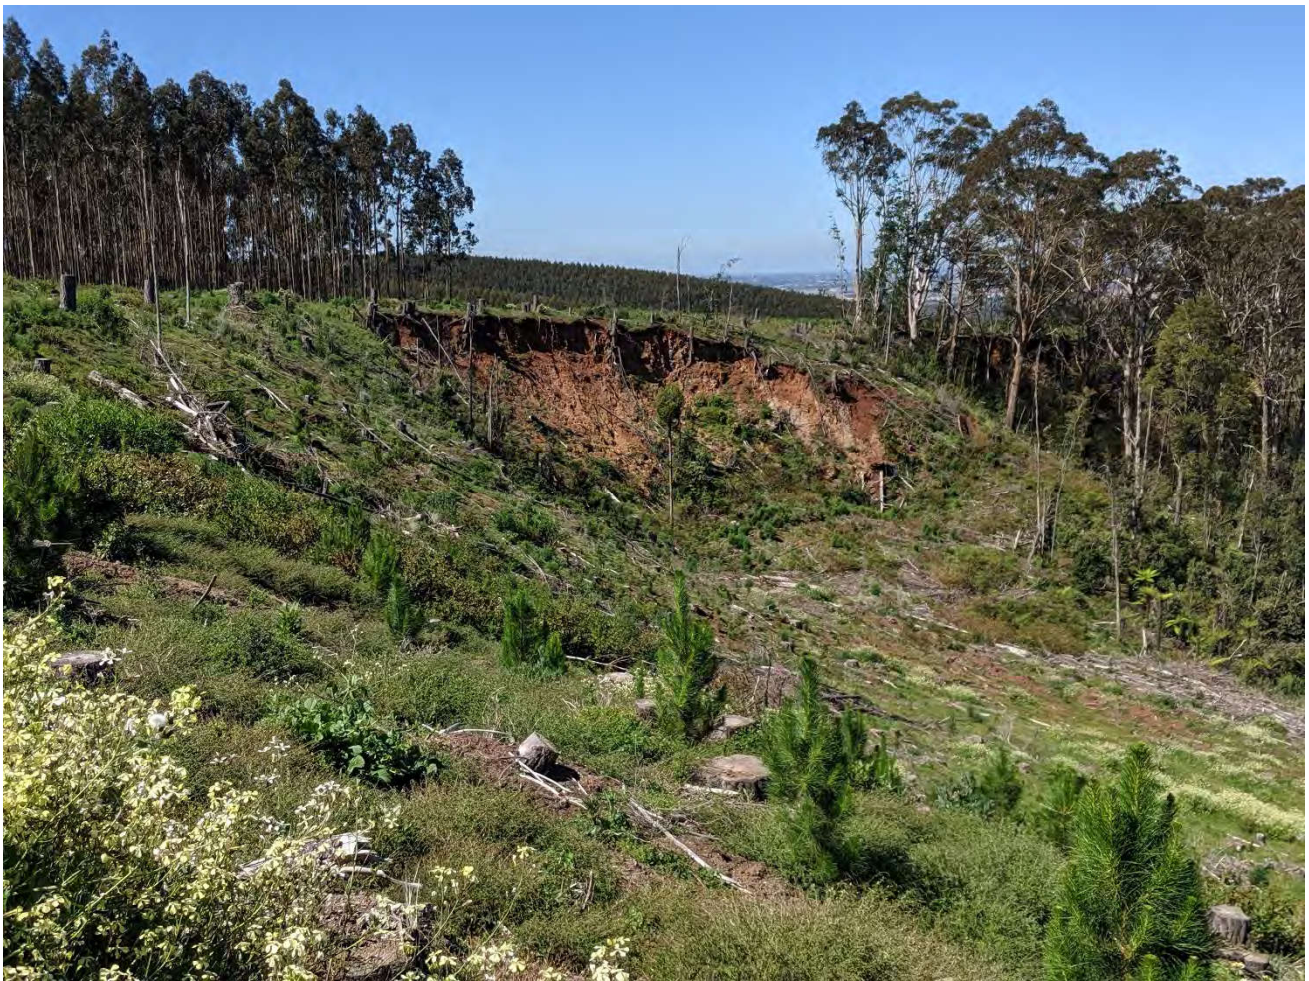
**Plate A5: Example of recent landslide, traverse between WTG 8 and WTG 9**

One example of a recent landslide was observed whilst traversing between WTG 8 and 9 (Plate A5), noting that the landslide was not observed to be at a WTG location. The landslide was observed to be about 30 m wide and had occurred on an approximately 30 degree slope, noting that this is one of the steepest slopes within the proposed wind farm area.

We note that no evidence for recent landslide activity was observed at any of the WTG locations visited during the site visit.
