# **Construction Impact Assessment**

Assessment of trees and vegetation patches at  
Delburn Wind farm

**Homewood Consulting Pty Ltd**

24 July 2020

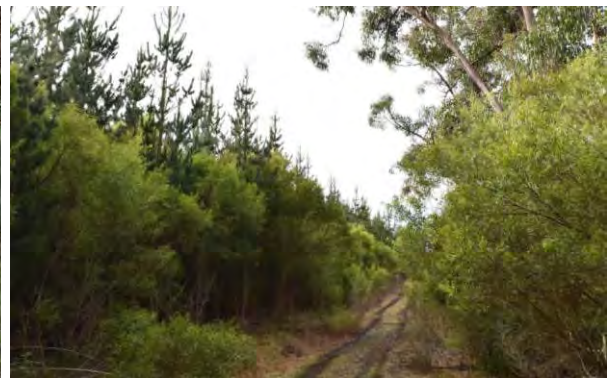
Figure 2: An unsealed access track passing through a pine plantation north of Creamery Rd, with Vegetation Patch 52 on the right-hand side.
